Hyperbaric Chamber Fires: Lessons Learnt

Dick Clarke, CHT

Primary Training in Hyperbaric Medicine
Columbia, South Carolina

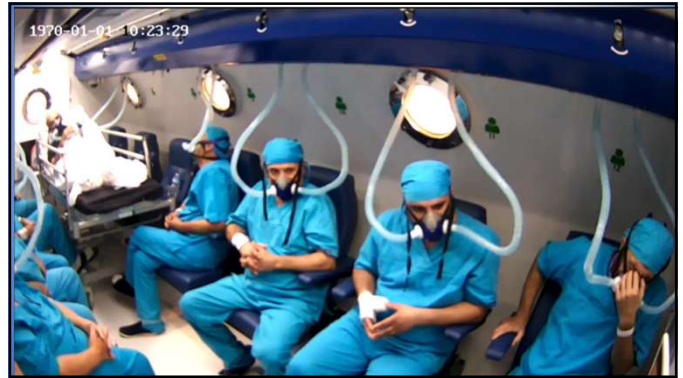
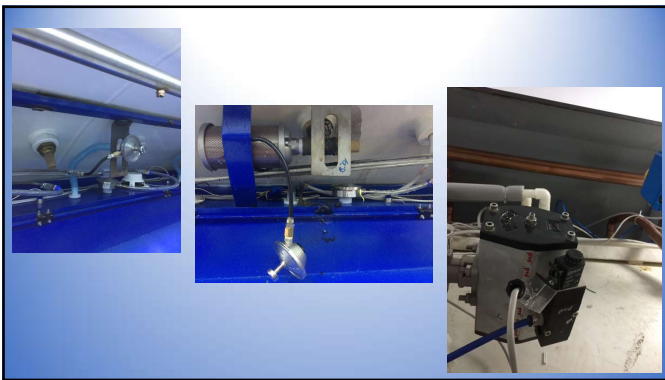
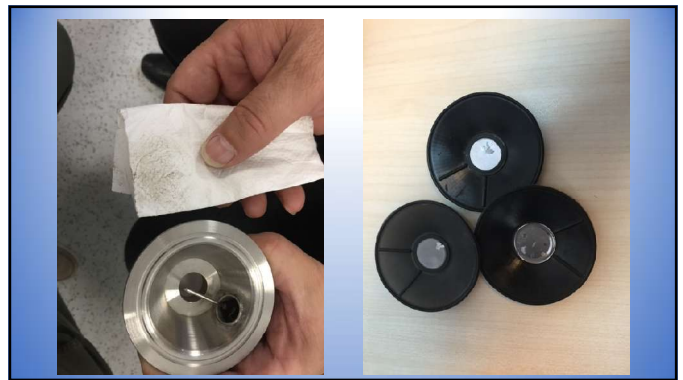
Inadequate system maintenance; particularly O2 delivery system cleanliness

Operational practices inconsistent with recognized standard of care

Physician entered chamber with cigarette lighter

Inadequate/non-existent emergency drills

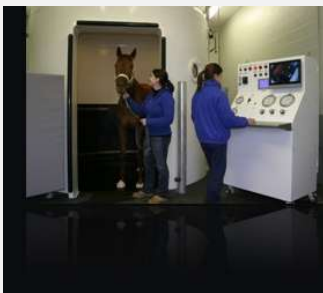
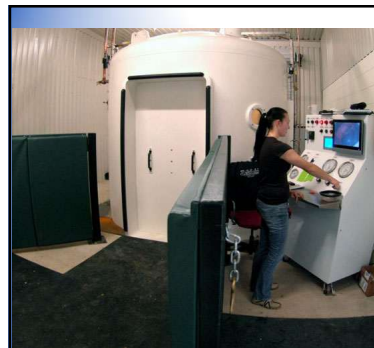
Steel oxygen-filled multiplace chamber
animal pt. fatality
chamber operator fatality

Patient treatment #5 underway
horse unsettled; kicking out
dislodged protective padding overlying steel hull
'massive spark' & flames per CCTV
urgent decompression initiated
