# Hyperbaric Chamber Fires

## *Lessons Learnt*

Primary Training in Hyperbaric Medicine  
Columbia, South Carolina

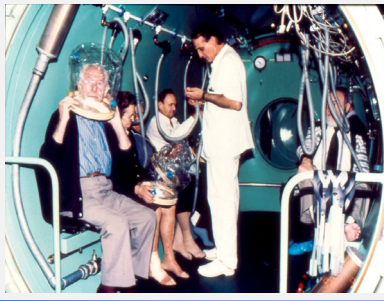
Multiplace chamber Milan, Italy  
personal clothes; synthetics/pockets  
no pt. or IA checks...pockets  
hood exhaust system disconnected  
"improperly modified hood latex neck seals allowed O2 to escape into pt. clothes making patients flammable cylinders"  
chamber O2 concentration commonly exceeded permissible limit  
"O2 monitor alarm manipulated"

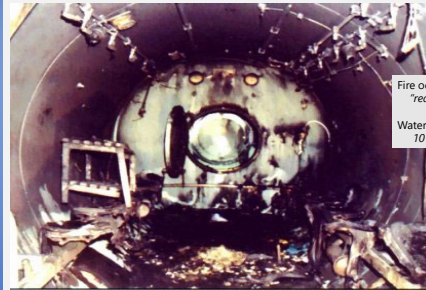
Fire occurred during compression  
"red flame explodes on screen, video goes black"  
Water deluge system activated...no water emitted  
10 pts 1 nurse quickly succumbed

"The fire extinguishing system was not functioning as the tank that was supposed to contain the water was empty, the propellant compressed air cylinder had the tap closed and the water supply hose valve was closed. The hand shower inside the hyperbaric chamber, foreseen in the design phase, had not been installed."

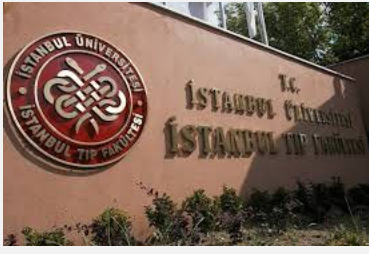
Istanbul University Medical Center

Multiplace chamber fire July 1998

3 fatalities: 2 divers, 1 physician

- Ongoing contamination O2 piping & valving; inadequate filtration
- Latter stages extended USN TT 6
- Chamber O2 atmosphere not monitored nor routinely flushed  
*one diver/pt. using mask with overboard exhaust, second using hood with inboard exhaust*
- Two "lightsaber-like" oxygen flames seen emitting (via viewport)  
*spontaneous ignition within regulators*
- Chamber operator did not/could not activate water deluge  
*Internal fire extinguisher not activated  
Flames only died out when oxygen system exhausted*
- Relief valves lifted (10 ATA)

Inadequate system maintenance; particularly O2 delivery system cleanliness

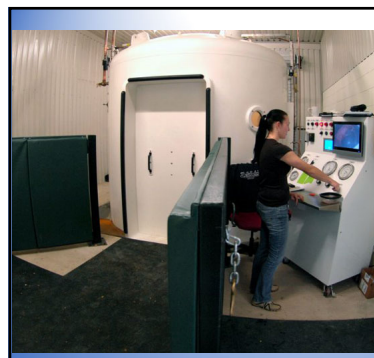
Patient treatment #5 underway  
*horse unsettled; kicking out  
dislodged protective padding overlying steel hull  
'massive spark' & flames per CCTV  
urgent decompression initiated*

Assistant ran to alert fire service; heard two explosions  
*first smaller, followed in ~1 second by massive one, as chamber exploded*  
*sound reported to have been heard several miles away*  
*piece of chamber went through apartment window > 2 miles away*

His coat contained oil-based lotion  
*not washed with approved soap per FSP*
